NUTE Case Study

Equalization Ponds Improvements

Sewerage Agency of Southern Marin (SASM)

Summer 2008

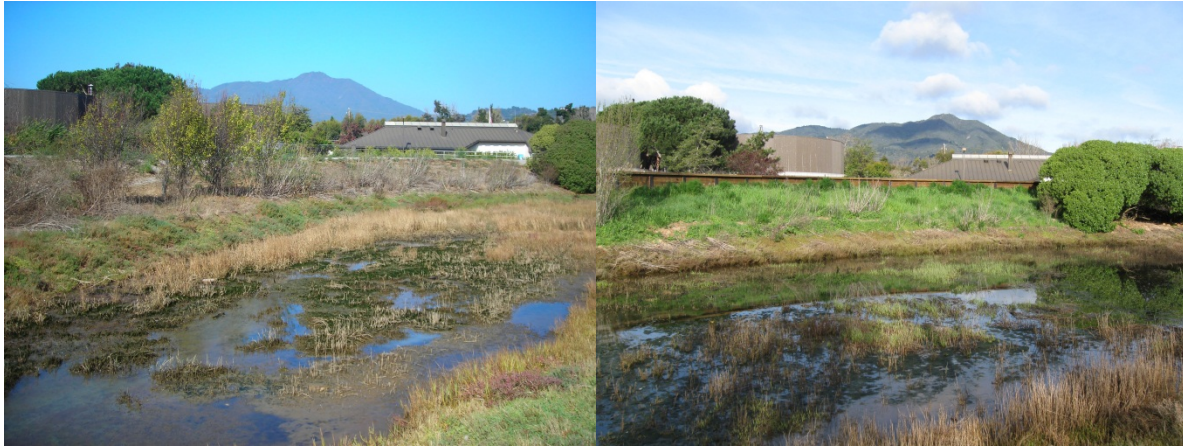
Figure 1: View of equalization pond berm before and after Nute Engineering Project in 2008 that more than doubled capacity of the ponds using a low-profile, HDPE-lined wood wall design. The tidal slough in the foreground was the location of sanitary sewer overflows in January 2008.

Solution: Nute Engineering quickly began work on a design alternatives technical memorandum that evaluated various approaches to increasing capacity of the equalization ponds. The larger south pond is managed in the summer as wildlife habitat using final effluent, as part of a cooperative agreement with neighborhood advocacy groups. In order to meet the aggressive timeline of increasing capacity by 1 million gallons by the following wet season, Nute recommended a low-profile wood retaining wall lined

by HDPE sheeting, incorporating three high berm areas to allow continued vehicular access around the ponds for maintenance and emergency access, and raising a concrete wall adjacent to the administrative building. The overflow weir structure would be elevated along with the exterior wall elevation, and the north pond (dry in the summer) would be carefully excavated to increase capacity but not damage the effluent force main that runs beneath it. A water level sensor was incorporated into the weir structure to enable operations staff to monitor water levels from the command center in the administration building.

Results: The project was bid in September 2008 and completed by December 2008 meeting the timeline goals for under \$500,000 in design and construction costs. The project increased the overall equalization capacity from 1.7 million gallons to 3.3 million gallons and had no community opposition because it retained the pedestrian trail and the popular wildlife habitat without altering the visual character of the area. All CEQA and permit processes went smoothly because of Nute's expertise and ability to convey the urgency of the project need through these processes. This project, adjacent to endangered species and other sensitive habitat and busy public parks, was completed within a year of the sewage spills that necessitated its construction, a significant accomplishment.

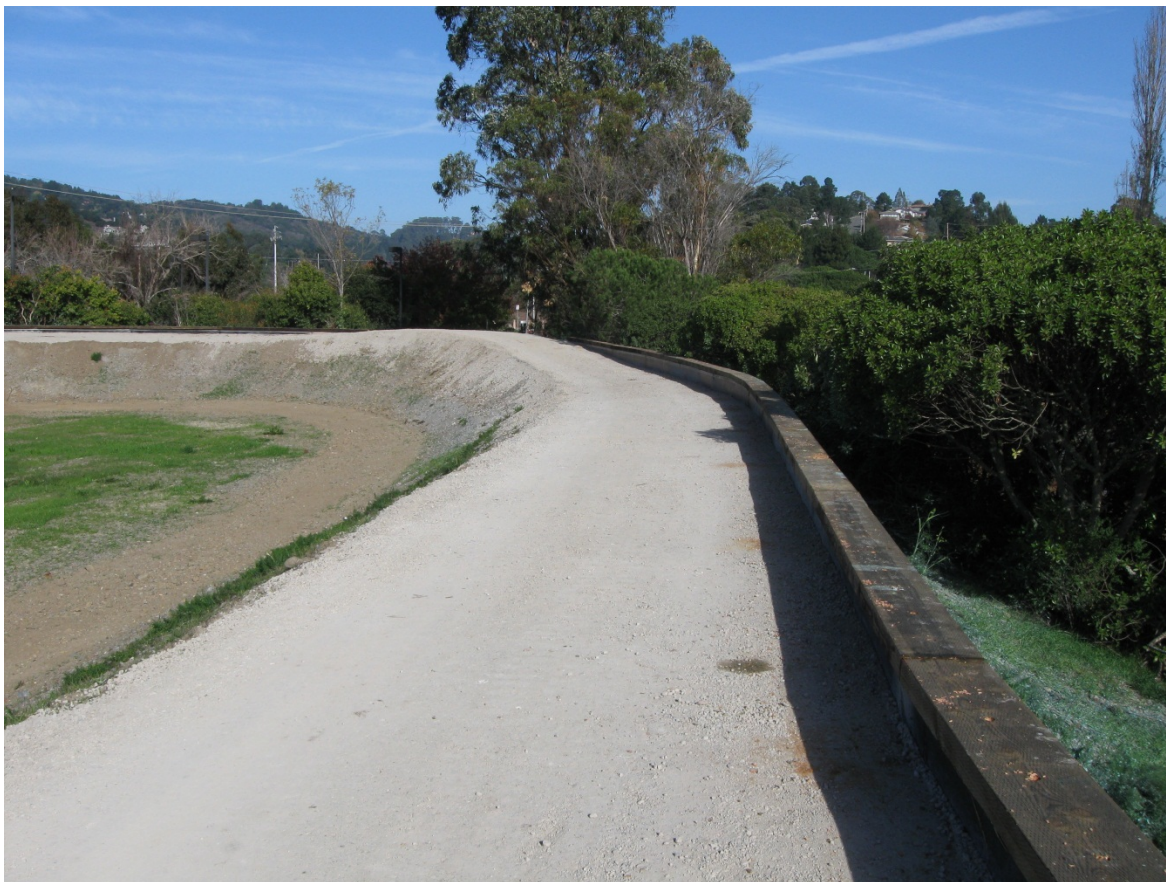
Figure 2: View of North Pond retaining wall and high berm for vehicular access to ponds.

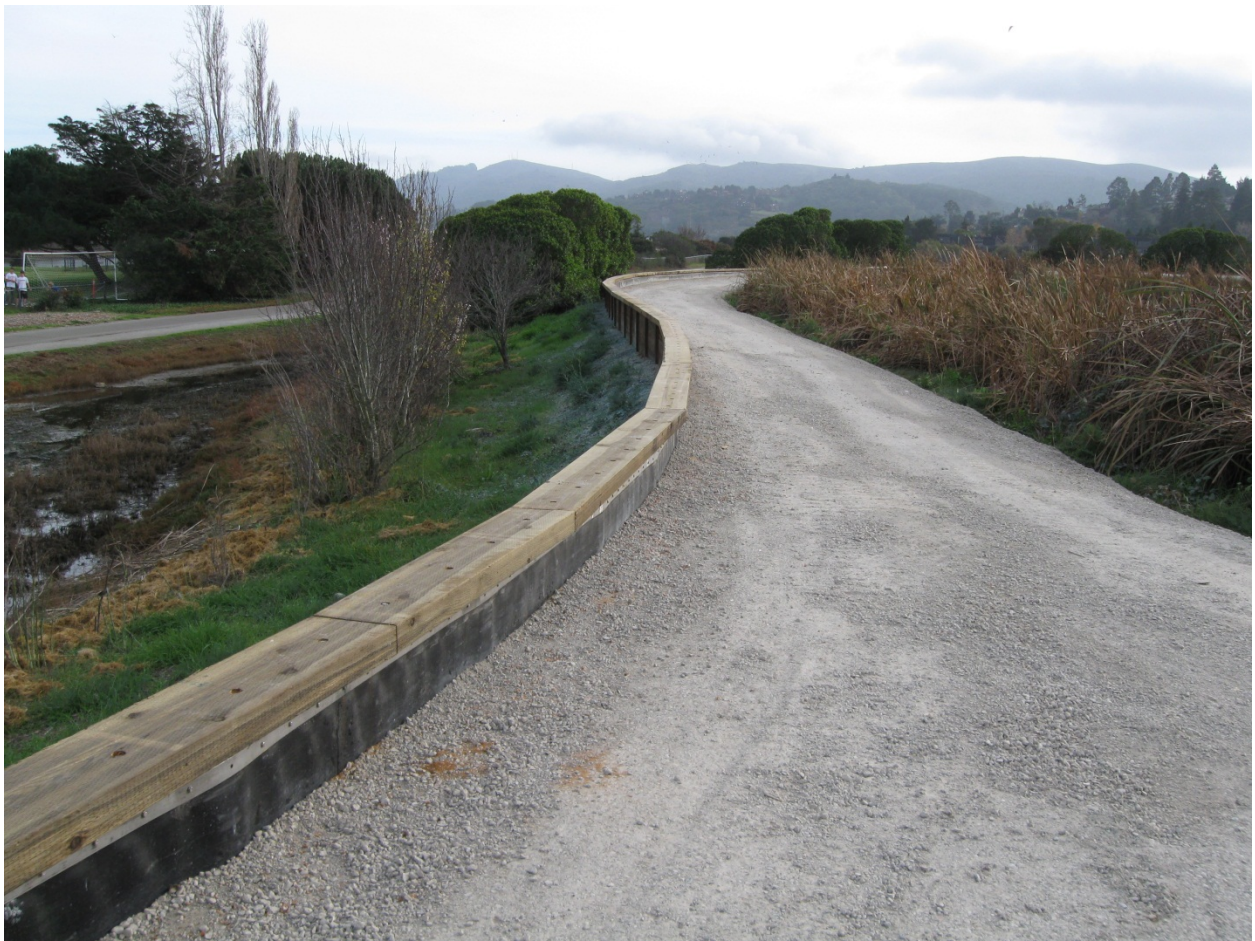
Figure 3: View of HDPE liner and wood wall next to the South Pond that provides wildlife viewing opportunities for local residents.

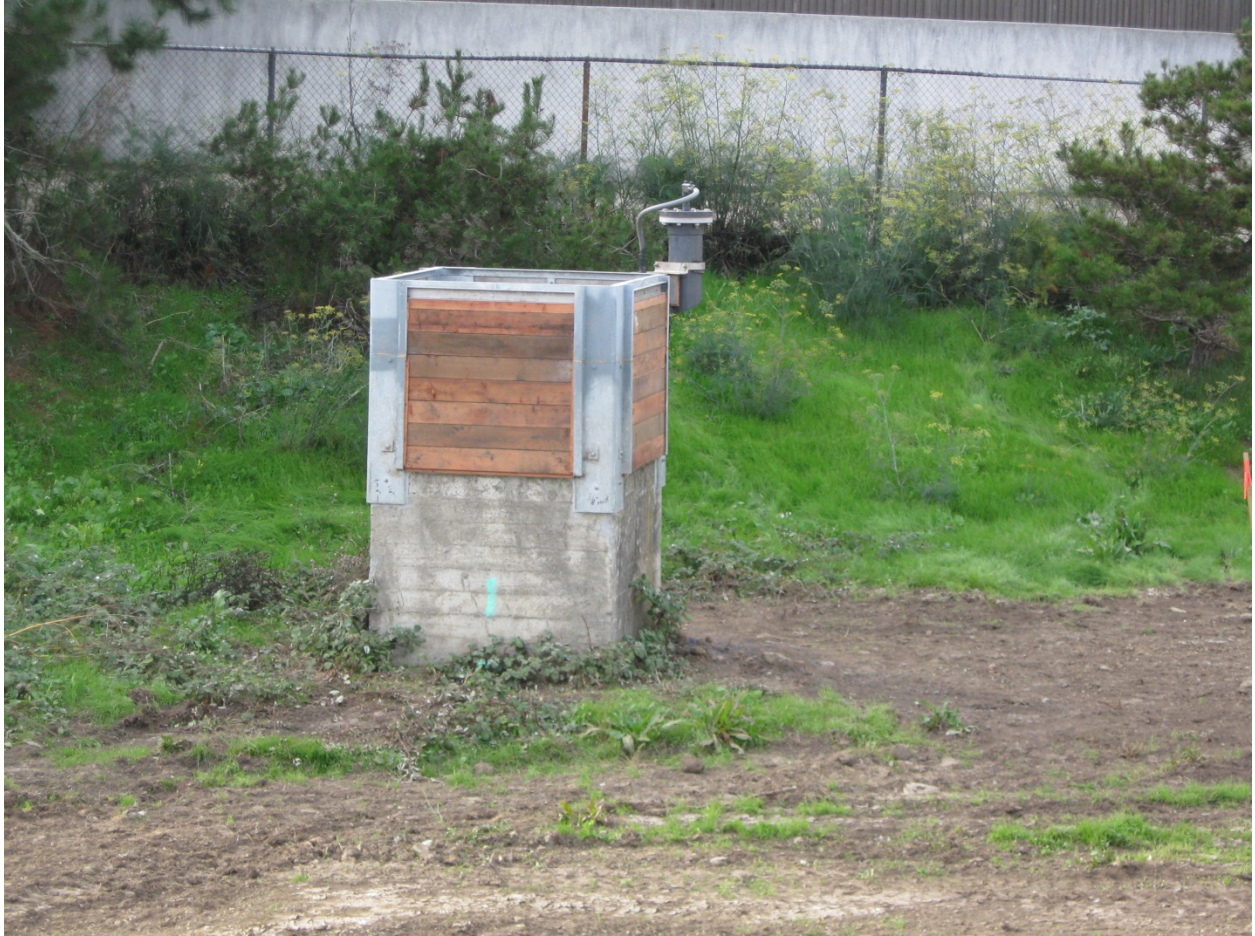
Figure 4: View of overflow weir box structure and water level sensor, showing welds on the steel structure that increased the elevation and capacity of the equalization ponds.
